APPENDIX M

WATER WELL ASSESSMENT

RE: ITC Lake Erie Connector, LLC Project Residential Water Well Risk Abatement Recommendation

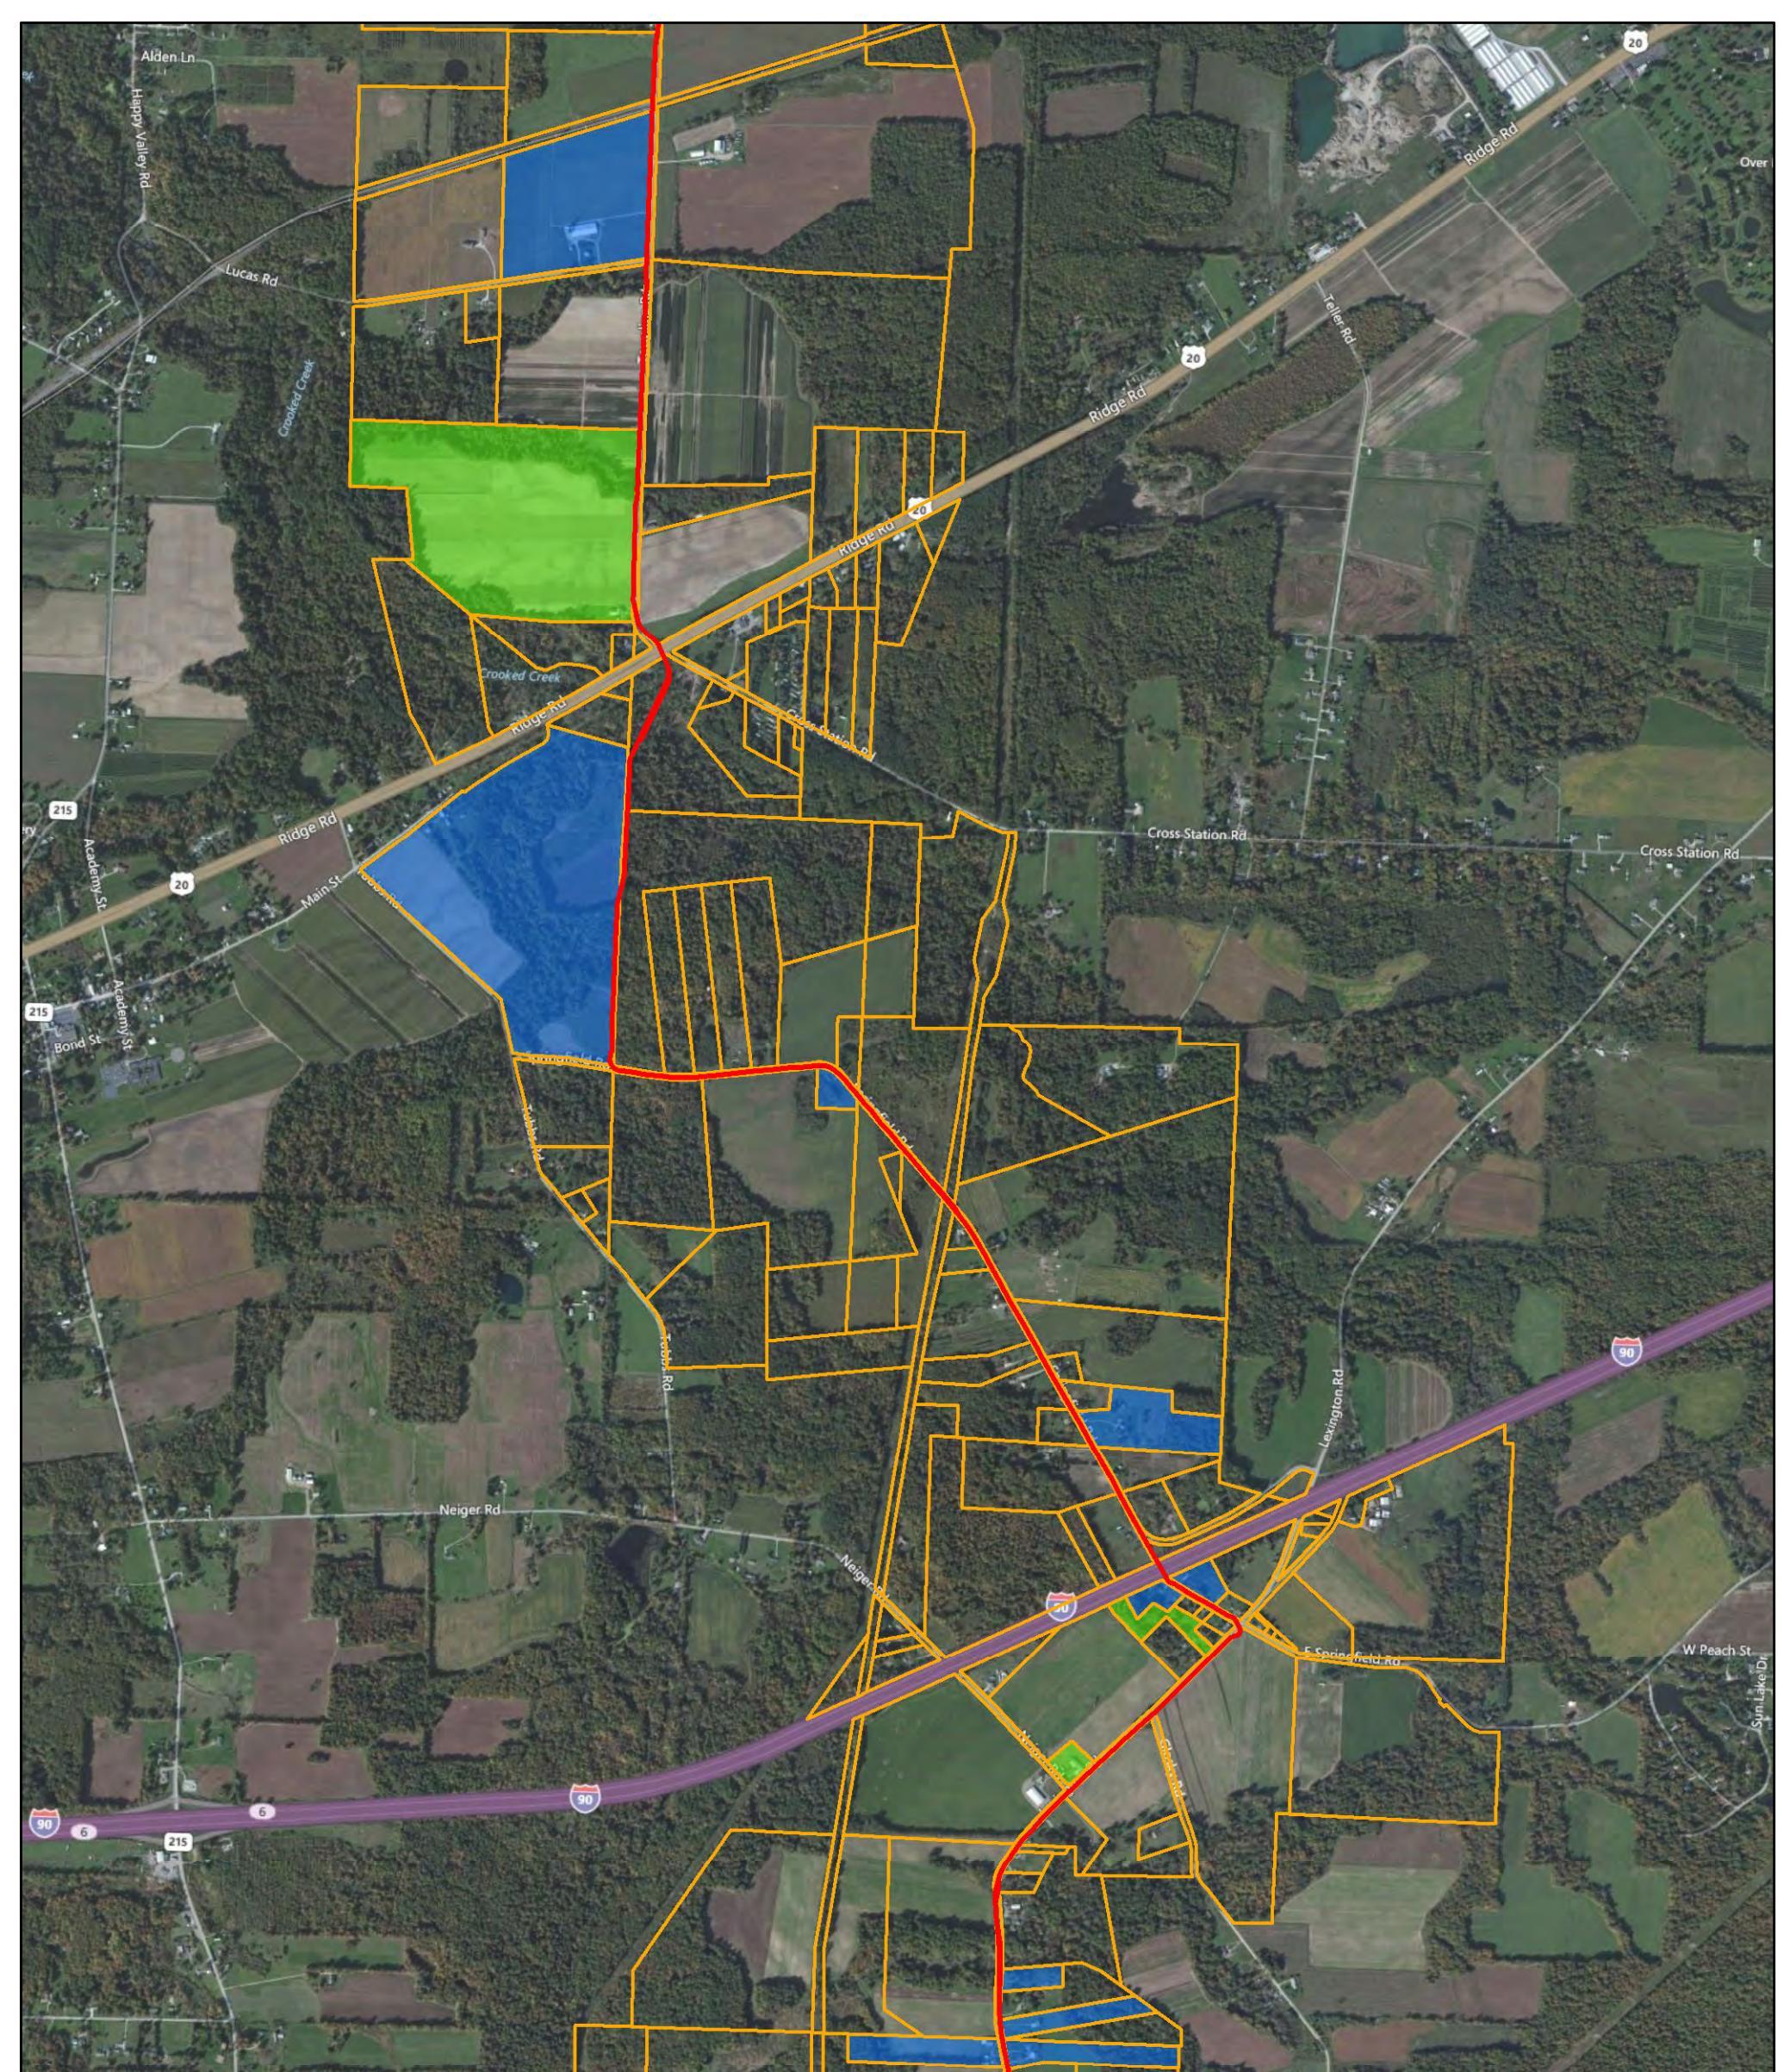
FIGURE 1

INITIAL RECORDED WATER LEVELS

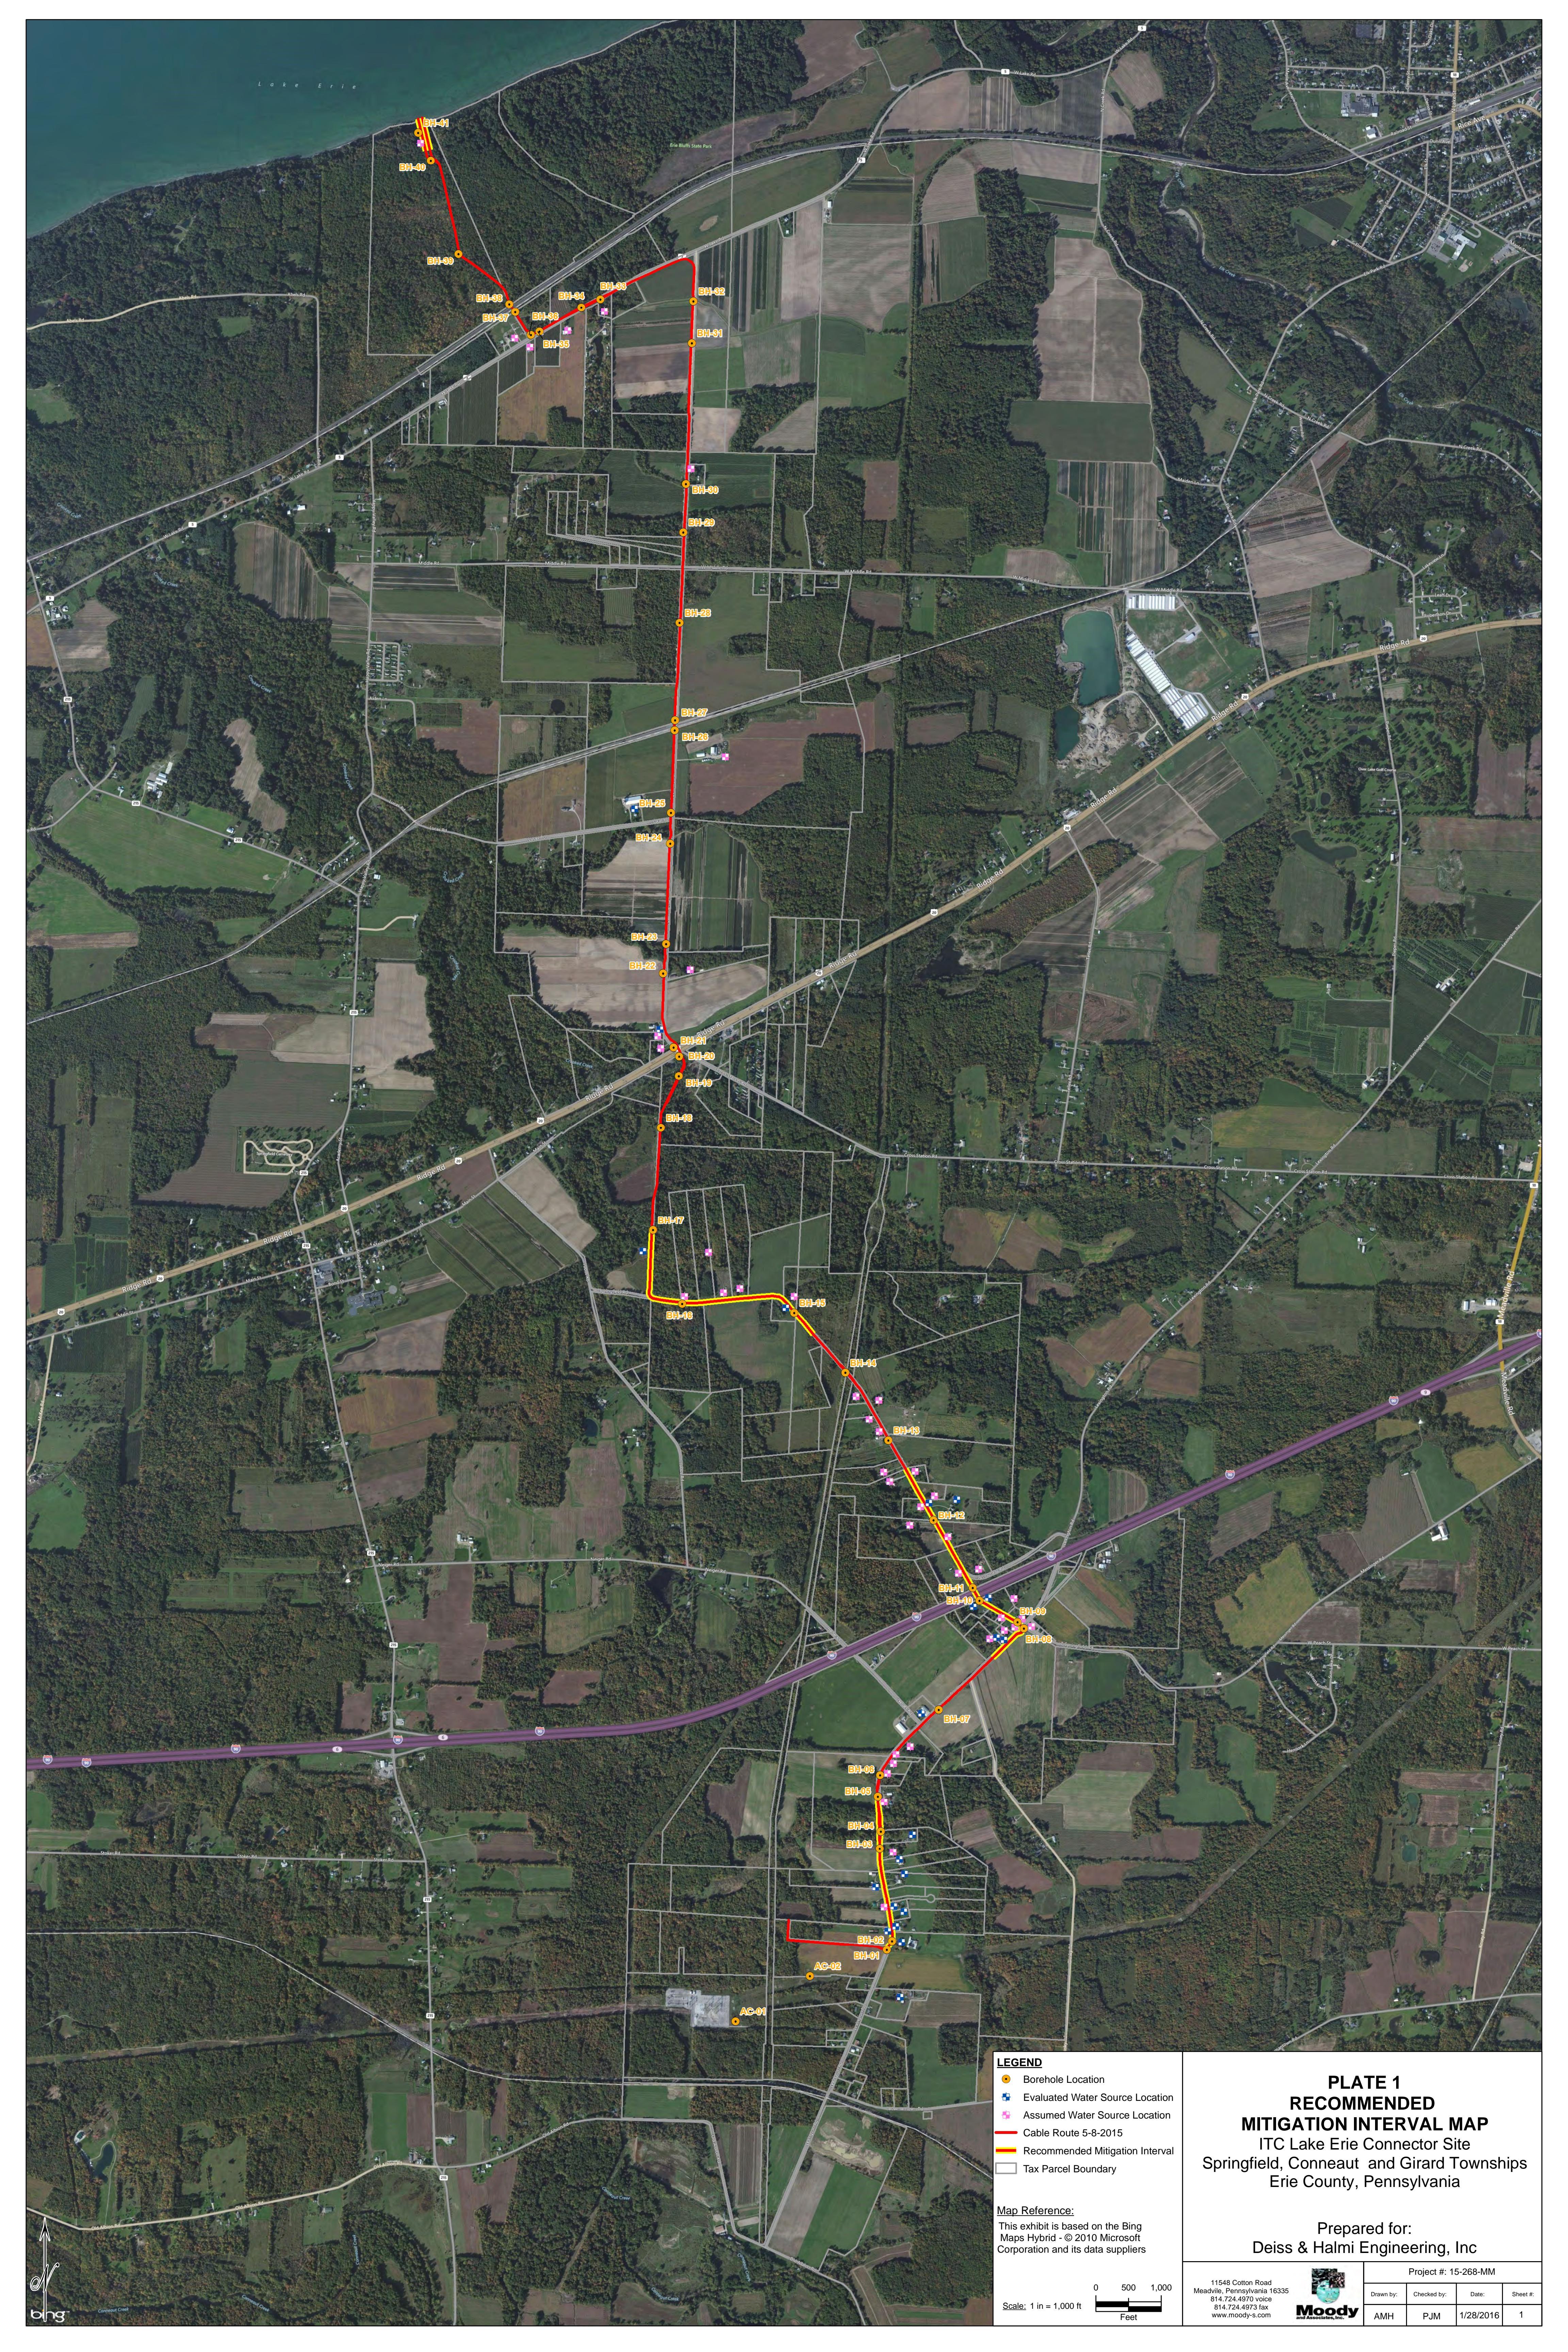
PLATE 1

- BH-04 has a low permeability interval from 4.0-7.5 feet bgs. There are water wells downgradient of this section of line and the recorded water levels (RWL) in these wells is high enough to be impacted by the low permeability interval. If groundwater is encountered during trench construction, mitigative procedures should be taken along this section of line, illustrated on PLATE 1.

wells is high enough to be impacted by the low permeability interval. If groundwater is encountered during trench construction, mitigative procedures should be taken along this section of line, illustrated on PLATE 1.

- BH-15 has a low permeability interval from 2.0-20.0 feet bgs. There are water wells downgradient of this section of line and the SWL in these wells is high enough to be impacted by the low permeability interval. If groundwater is encountered during trench construction, mitigative procedures should be taken along this section of line, illustrated on PLATE 1.

- BH-16 has a low permeability interval from 4.5-10.0 feet bgs. There are water wells downgradient of this section of line but the SWL of these wells is unknown at this time. If groundwater is encountered during trench construction, mitigative procedures should be taken along this section of line, illustrated on PLATE 1.

- BH-20 has a low permeability interval from 1.5-10.0 feet bgs. There are water wells downgradient of this section of line and the SWL in these wells is high enough to be impacted by the low permeability interval. If groundwater is encountered during trench construction, mitigative procedures should be taken along this section of line, illustrated on PLATE 1.

- BH-39 has a low permeability interval from 0.7-4.5 feet bgs. The duct bank will be deeper than this interval. Mitigative procedures are unnecessary.
- BH-41 has a low permeability interval from 4.5-7.5 feet bgs. There are water wells downgradient of this section of line but the SWL of these wells is unknown at this time. If groundwater is encountered during trench construction, mitigative procedures should be taken along this section of line, illustrated on PLATE 1.

Moody recommends that in order to minimize risk of impact, mitigative techniques may need to be employed in the construction of the cable trench. Sections of the line in which the impermeable barrier may affect local water wells are illustrated on PLATE 1. Mitigation should be considered along those intervals, and especially when shallow groundwater is encountered during the construction of the trench. Channels oriented perpendicular to the direction of the trench should be incorporated into the trench bottom along intervals of concern. The channels should be not less than one foot wide and one foot deeper than the prevailing depth of the trench, and should be backfilled with a permeable material that will permit groundwater flow beneath the line. Additionally, the channels should be constructed at intervals not greater than ten feet along the length of the section of concern. In addition, Moody recommends that dewatering activities are kept at the minimum level necessary to facilitate construction activities. Excessive dewatering of the trench may lead to alteration of the preexisting groundwater flow gradient and reduced yield in adjacent water wells.
